**Flood Control Project Maintenance  
Levee Inspections**

**Fall 2018 Levee Maintenance Deficiency Summary Report**

**Reclamation District No. 1601 Twitchell**

Waterway			Bank	Unit Miles
Unit No. 01 Threemile Slough			Left	2.43
	Spring (March - May)	Summer (June - August)	(September - November) Fall	Winter (December - February)
Unit Maintenance Rating (Fall Only)			<b>A</b>	
Date of Inspection	3/22/2018 - 3/22/2018		10/12/2018 - 10/12/2018	
DWR Inspector	Keith Millard		David Julian	
Accompanied By	Rick Carter RD1601		Rick Carter RD1601

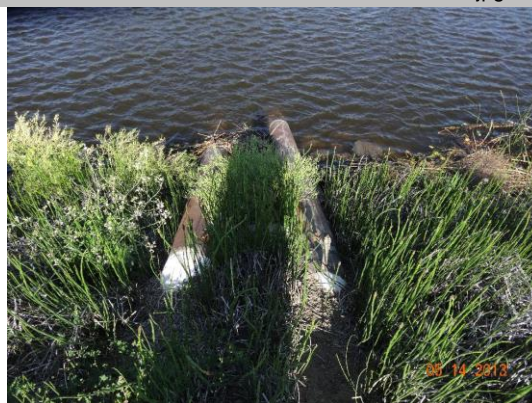
Photo 1 of 3 : UCIP\_FA\_2018\_22043\_37621.jpg

Comment Code					
Inspector Comment					
FS_ID:22043 DS_ID:20950 EP_NO: 11227 Repair Type: Non-Urgent Crossing Status: Found UCIP Comments: Appears this crossing might be been recently modified--exposed section of pipe is protected with white paint. Need to contact owner to obtain records. Recommend clearing vegetation along the pipe alignment. FIELD_STRUCT_DESC: 14-inch pipe (not 12-inch pipe as original description noted) through the levee, 4 feet below the crown. Siphon primer on waterside (WS) shoulder. 36-inch steel (not concrete as original description noted) pipe with shut-off valve inside at landside (LS) toe ditch. (12-inch pipe authorized under Automatic Board Order (ABO) issued as Permit No. 11227, 1975-Standard Oil of California; no permit found for 14-inch pipe) [Additional Reference(s): DWR Levee Logs, 2005] FS Date: 5/14/2013

View of waterward side. 12-inch pipe to the right and 14-inch pipe to the left.

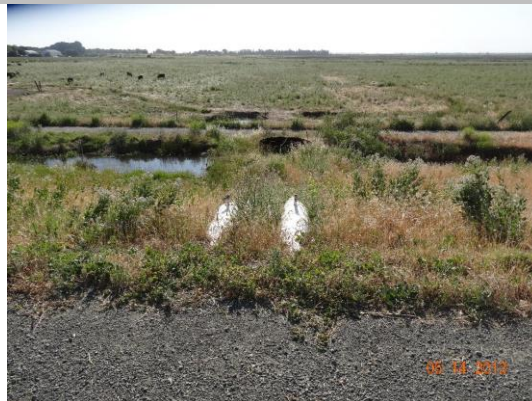
Photo 2 of 3 : UCIP\_FA\_2018\_22043\_37622.jpg

View of landward side with canal located at toe.

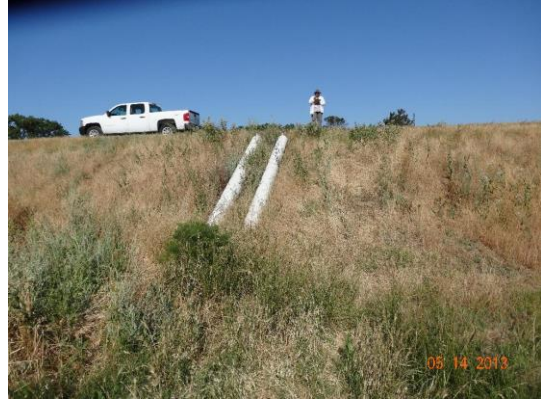
Photo 3 of 3 : UCIP\_FA\_2018\_22043\_37624.jpg

Comment Code						
Inspector Comment						
FS_ID:22043 DS_ID:20950 EP_NO: 11227 Repair Type: Non-Urgent Crossing Status: Found UCIP Comments: Appears this crossing might be been recently modified--exposed section of pipe is protected with white paint. Need to contact owner to obtain records. Recommend clearing vegetation along the pipe alignment. FIELD_STRUCT_DESC: 14-inch pipe (not 12-inch pipe as original description noted) through the levee, 4 feet below the crown. Siphon primer on waterside (WS) shoulder. 36-inch steel (not concrete as original description noted) pipe with shut-off valve inside at landside (LS) toe ditch. (12-inch pipe authorized under Automatic Board Order (ABO) issued as Permit No. 11227, 1975-Standard Oil of California; no permit found for 14-inch pipe) [Additional Reference(s): DWR Levee Logs, 2005] FS Date: 5/14/2013

View of pipes located on landward side-dense vegetation along slope.

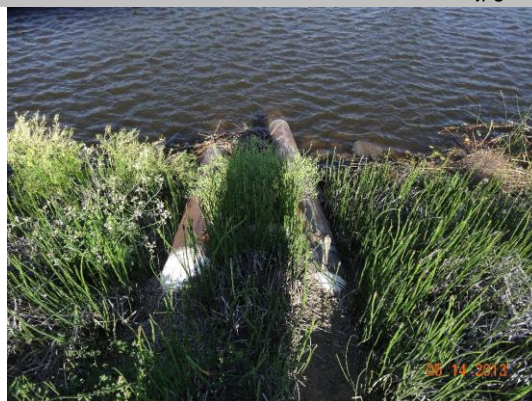
Photo 1 of 3 : UCIP\_FA\_2018\_42024\_60809.jpg

Comment Code						
Inspector Comment						
FS_ID:42024						
DS_ID:20953						
EP_NO: N/A						
Repair Type: Non-Urgent						
Crossing Status: Found						
UCIP Comments: Appears this crossing might have been recently modified--O&M manual calls for 8 inch pipe not 12 inch pipe, need additional information--exposed section of pipe is protected with white paint. Need to contact owner to obtain records. Recommend clearing vegetation along the pipe alignment.						
FIELD_STRUCT_DESC: 12-inch (not 8 inch listed in USACE) siphon through the levee approximately 3.2 feet below the crown. The existing 8-inch pipe listed in the O&M manual is no longer present, no permit was found authorizing crossing modifications. [Additional Reference(s): USACE Sacramento O&M Manual Unit No. 102, April 1959, (HLM 0.1), 8-inch pipe]						
FS Date: 5/14/2013

View of waterward side. 12-inch pipe on the right (u/s) and 14-inch pipe on the left (d/s).

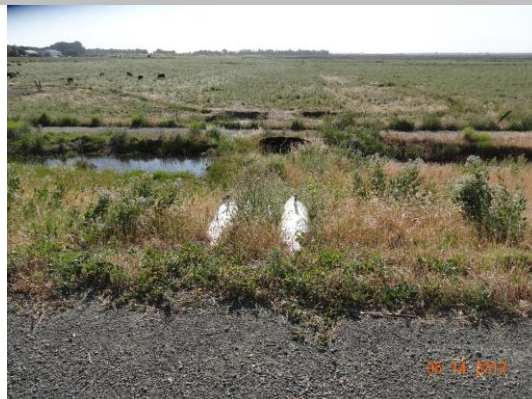
Photo 2 of 3 : UCIP\_FA\_2018\_42024\_60810.jpg

View of pipes from landward shoulder. Levee is a gravel road.

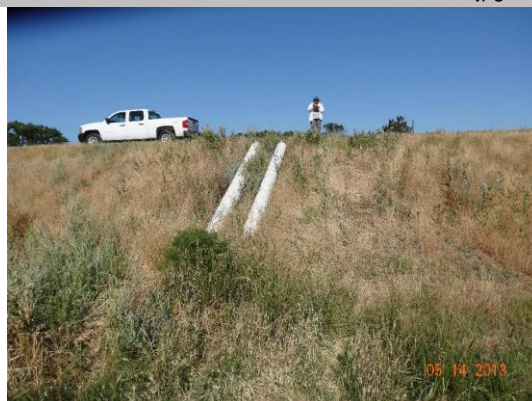
Photo 3 of 3 : UCIP\_FA\_2018\_42024\_60812.jpg

Comment Code						
Inspector Comment						
FS_ID:42024						
DS_ID:20953						
EP_NO: N/A						
Repair Type: Non-Urgent						
Crossing Status: Found						
UCIP Comments: Appears this crossing might have been recently modified--O&M manual calls for 8 inch pipe not 12 inch pipe, need additional information--exposed section of pipe is protected with white paint. Need to contact owner to obtain records. Recommend clearing vegetation along the pipe alignment.						
FIELD_STRUCT_DESC: 12-inch (not 8 inch listed in USACE) siphon through the levee approximately 3.2 feet below the crown. The existing 8-inch pipe listed in the O&M manual is no longer present, no permit was found authorizing crossing modifications. [Additional Reference(s): USACE Sacramento O&M Manual Unit No. 102, April 1959, (HLM 0.1), 8-inch pipe]						
FS Date: 5/14/2013

View of pipes on landward side-dense vegetation along slope.

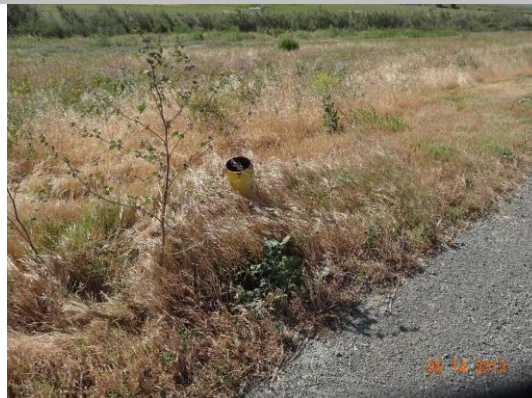
Photo 1 of 3 : UCIP\_FA\_2018\_52959\_71862.jpg

Comment Code					
Inspector Comment					
FS_ID:52959 DS_ID:24069 EP_NO: N/A Repair Type: Non-Urgent Crossing Status: Indicator Found UCIP Comments: 03/08/2018 No supporting documentation was received for this crossing by KSN Inc. to determine the fate of this encroachment. Need to contact KSN Inc. (Dcarr@KSNinc.com) to obtain documentation for the removal or abandonment of encroachment. (O. Magana - DWR UCIP) 03/19/2009 Unable to determine if line crosses levee. Need to contact owner to determine if crossing goes through levee. Also need to determine permit authorizing work on landward side. (O. Magana - DWR UCIP) FIELD_STRUCT_DESC: Steel stand pipe with PVC pipe inside located on landside (LS) shoulder. Rip rap located on waterside (WS) slope. Unable to determine if crossing goes through levee. Appears to be monitoring gas well. FS Date: 3/19/2009

View of landward side--standpipe located on slope.

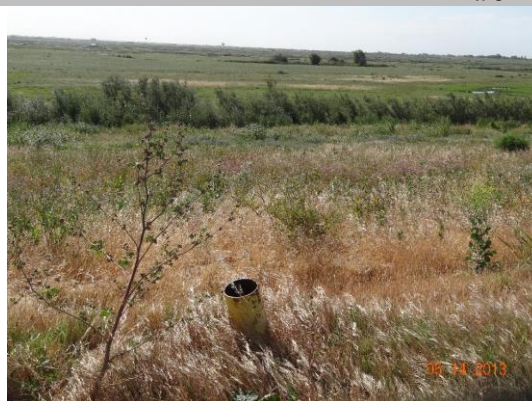
Photo 2 of 3 : UCIP\_FA\_2018\_52959\_71860.jpg

View of landward side--dense vegetation along slope.

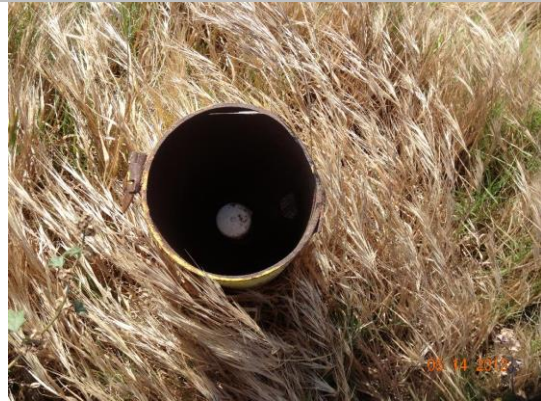
Photo 3 of 3 : UCIP\_FA\_2018\_52959\_71861.jpg

Comment Code						
Inspector Comment						
FS_ID:52959 DS_ID:24069 EP_NO: N/A Repair Type: Non-Urgent Crossing Status: Indicator Found UCIP Comments: 03/08/2018 No supporting documentation was received for this crossing by KSN Inc. to determine the fate of this encroachment. Need to contact KSN Inc. (Dcarr@KSNinc.com) to obtain documentation for the removal or abandonment of encroachment. (O. Magana - DWR UCIP) 03/19/2009 Unable to determine if line crosses levee. Need to contact owner to determine if crossing goes through levee. Also need to determine permit authorizing work on landward side. (O. Magana - DWR UCIP) FIELD_STRUCT_DESC: Steel stand pipe with PVC pipe inside located on landside (LS) shoulder. Rip rap located on waterside (WS) slope. Unable to determine if crossing goes through levee. Appears to be monitoring gas well. FS Date: 3/19/2009

PVC pipe inside standpipe located on landward side.

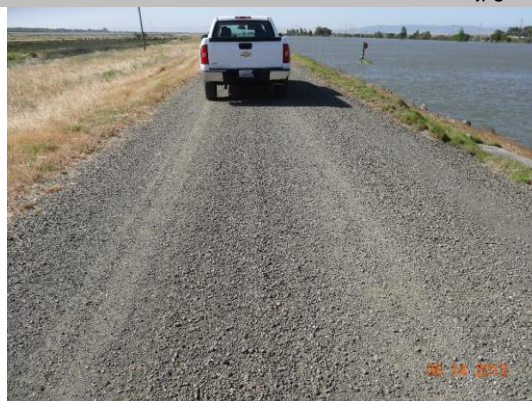
Photo 1 of 3 : UCIP\_FA\_2018\_19545\_33173.jpg

Comment Code						
Inspector Comment						
FS_ID:19545 DS_ID:20951 EP_NO: 2909A Repair Type: Non-Urgent Crossing Status: Found UCIP Comments: Appears this crossing might be been recently modified--exposed section of pipe is protected with white paint. Need to contact owner to obtain records. Recommend clearing vegetation along the pipe alignment. Dense vegetation on landward slope limits the inspector's visibility to identify signs of leaks along levee slope. FIELD_STRUCT_DESC: 8-inch siphon irrigation pipe through levee, 2.4 feet below crown. Cutoff wall around pipe at center of levee. Siphon breaker on apex of pipe on landside (LS) shoulder. Hand primer pump on LS slope. (8-inch pipe authorized under Permit No. 2909A, 1960-J. Souza). [Additional Reference(s): DWR Levee Logs, 2005] FS Date: 5/14/2013

View of levee crown looking downstream at crossing.

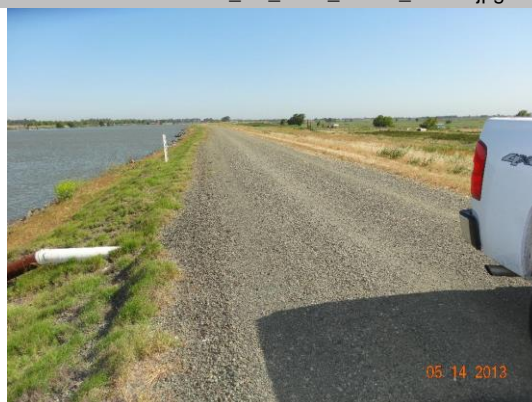
Photo 2 of 3 : UCIP\_FA\_2018\_19545\_33174.jpg

View of levee crown looking upstream at crossing.

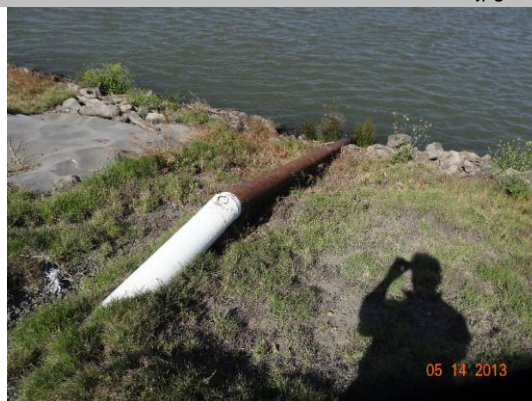
Photo 3 of 3 : UCIP\_FA\_2018\_19545\_33171.jpg

Comment Code						
Inspector Comment						
FS_ID:19545 DS_ID:20951 EP_NO: 2909A Repair Type: Non-Urgent Crossing Status: Found UCIP Comments: Appears this crossing might be been recently modified--exposed section of pipe is protected with white paint. Need to contact owner to obtain records. Recommend clearing vegetation along the pipe alignment. Dense vegetation on landward slope limits the inspector's visibility to identify signs of leaks along levee slope. FIELD_STRUCT_DESC: 8-inch siphon irrigation pipe through levee, 2.4 feet below crown. Cutoff wall around pipe at center of levee. Siphon breaker on apex of pipe on landside (LS) shoulder. Hand primer pump on LS slope. (8-inch pipe authorized under Permit No. 2909A, 1960-J. Souza). [Additional Reference(s): DWR Levee Logs, 2005] FS Date: 5/14/2013

View of crossing on waterward slope. Rip rap present at waterward toe.
